## CLACHNABEN FOOTPATH

*DONALD THOMAS*

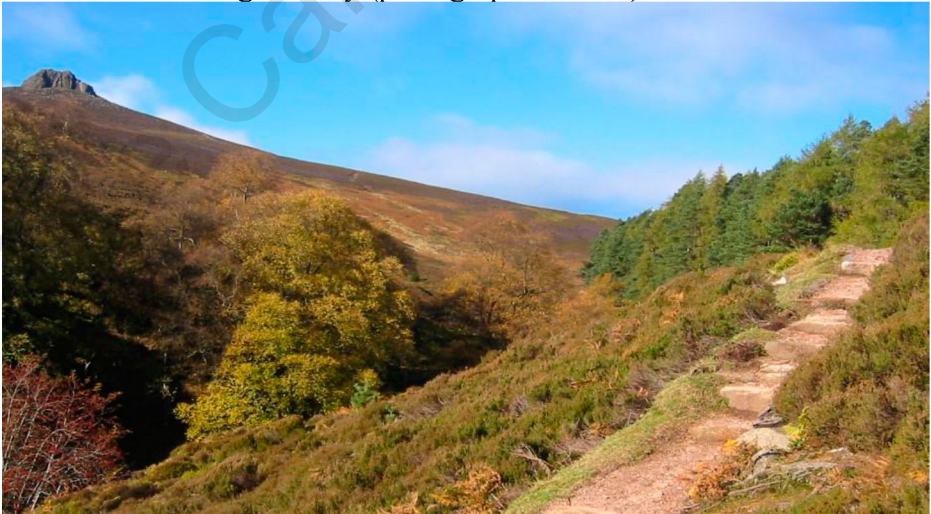
1 The Tor in Sight

In recent years the Club has carried out repairs to the Clachnaben footpath. There has been a path here for many years, enabling generations of walkers to reach the summit tor on this fine hill. An estate track crosses flat ground (“Miller’s Bog”) from where several routes made their way through the plantation to emerge at the foot of the hill proper. From there, the most direct “desire line” ascended over peat, passing several springs. With continued trampling, the peat was much eroded with a progressively widening and braided path, as walkers avoided the soft, wet ground. In the mid 1990’s, the late Jim Maison, a walker from Forfar, realised that the state of the path was largely due to visitors and had little to do with estate activities. He set about tackling the problem. With several other walkers drawn from local clubs, he formed a trust which was supported by Aberdeenshire Council, Scottish National Heritage (SNH) and Texaco. Over the following years, the trust funded contractors to repair the worst of the damage. The landowner, Charles Gladstone provided accommodation for the workers and had three pedestrian bridges constructed where the landrover track fords streams. He favoured a single line along the lower edge of the woodland, which had the benefit of views of the summit along the way (photograph 1 below).

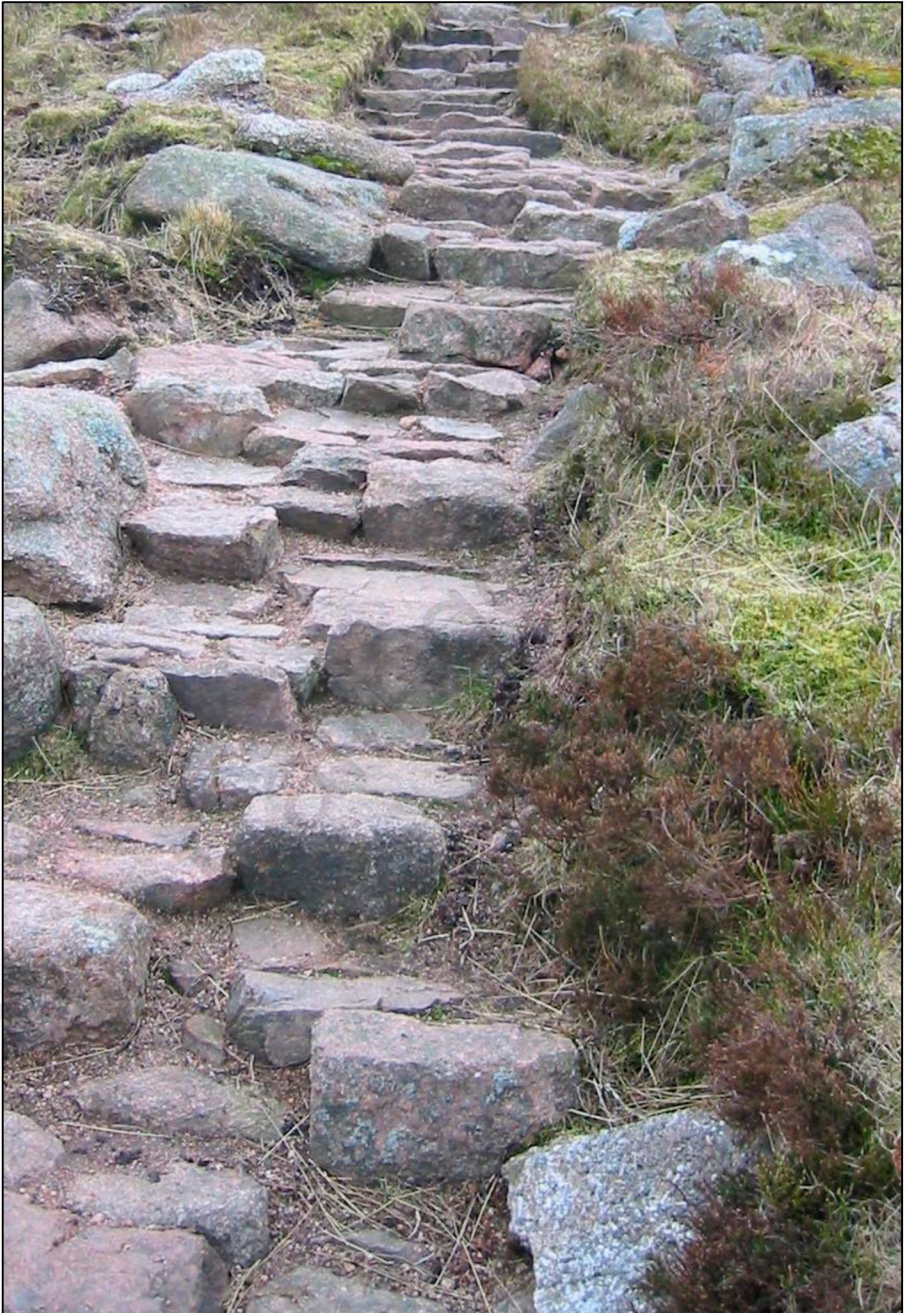
2 Stone Pitching

Too steep in places for an aggregate path, much of the new section is stone pitching. Most work on the hill was carried out by hand, with a power barrow and limited use of a mini excavator. Some of the stone for drainage features (photograph 2 on the following page) was moved from elsewhere on the estate by helicopter. Once the full length of path was in good repair, little maintenance was carried out, beyond removing fallen trees and occasional clearing of cross drains (photograph 3 the following pages). The hill remained popular with successive generations of walkers, with an estimated 10,000 visitors per year. The estate established a small car park in a former quarry, replacing roadside parking.

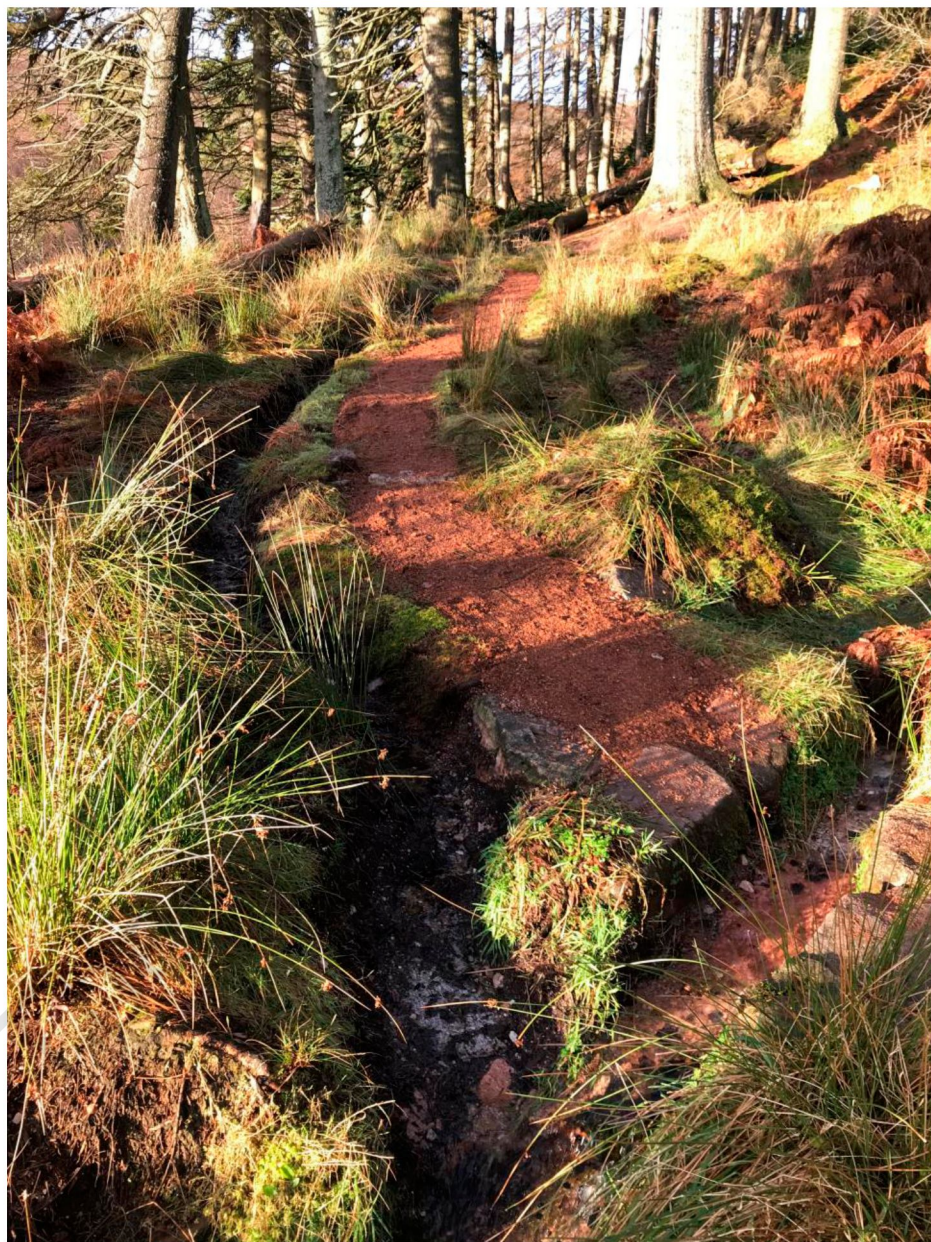
3 Cross Drain and ditching (funded by the Club)

In 2017, the Cairngorm Club was alerted to the need for some fresh work. Several sections were eroded and there was a further fallen tree. Metal pins, once securing logs at the side of the path, now protruded into the walking surface in several places. The Club successfully applied for a lottery grant, enabling a detailed survey (by the Outdoor Access Trust for Scotland) and the priority remedial work (by ACT Heritage) to be carried out. The Club, North East Mountain Trust and Ramblers Scotland made additional financial contributions towards this work. Volunteers from the John Muir Trust NE Scotland local group have cleared drains on several occasions.

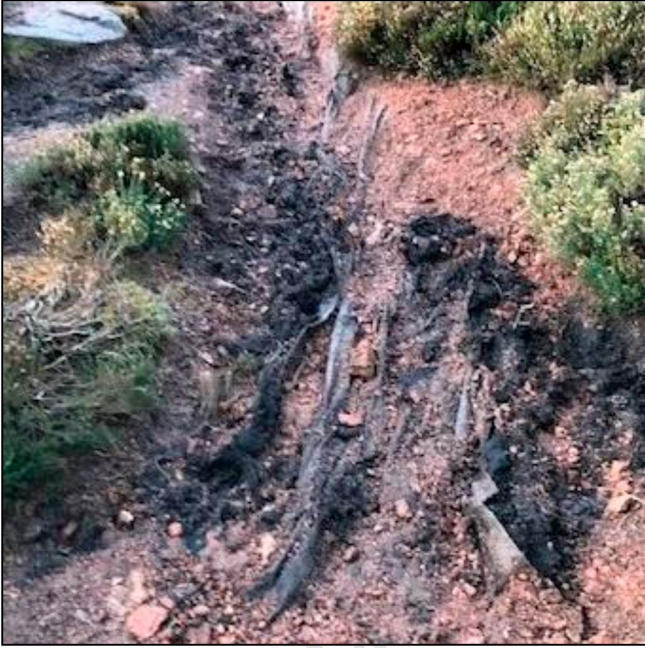
The estate has recently (2021) changed hands and we await an indication of the new owner’s willingness to allow or support further work. One section is badly eroded, another is often wet and recent storms have brought down trees on the path (photographs 4&5 on the following pages).

4 Path Erosion awaiting repair

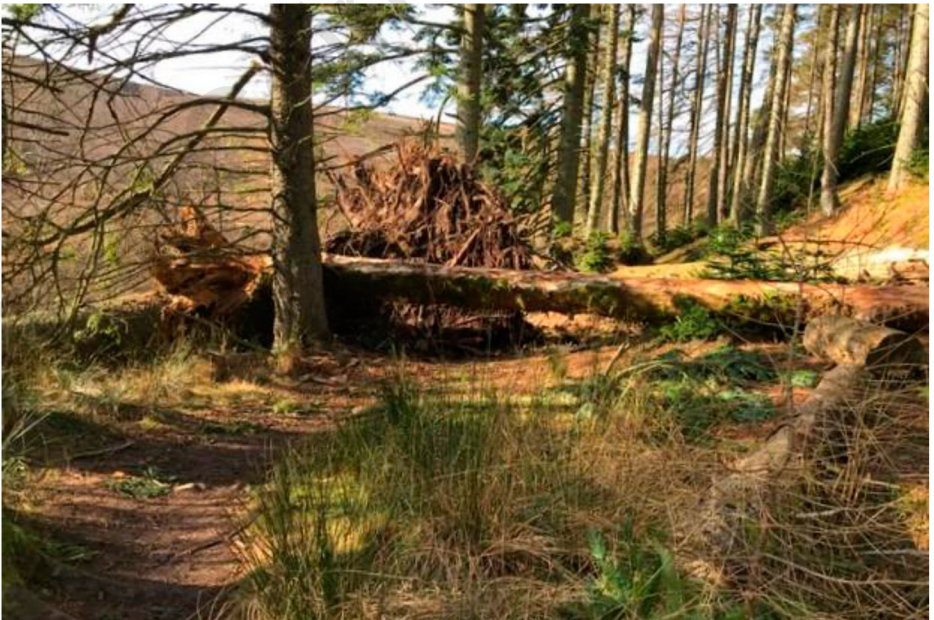
5 Fallen Trees (2022)
